UNITED STATES ENVIRONMENTAL PROTECTION AGENCY  
REGION III  
1650 Arch Street  
Philadelphia, Pennsylvania 19103-2029

**Inspection Date(s):** 9/18/2017 – 9/21/2017

**Company name:** Antero Resources

**Facility Name:** Hamilton, Estlack, Weigle East, Eddy, Primm, Robert Williams, Fritz, Lockhart Heirs, Charlene, Walnut West, Diane Davis, Ness, John Richards, Edwin, Mackay, and Rock Run well pads

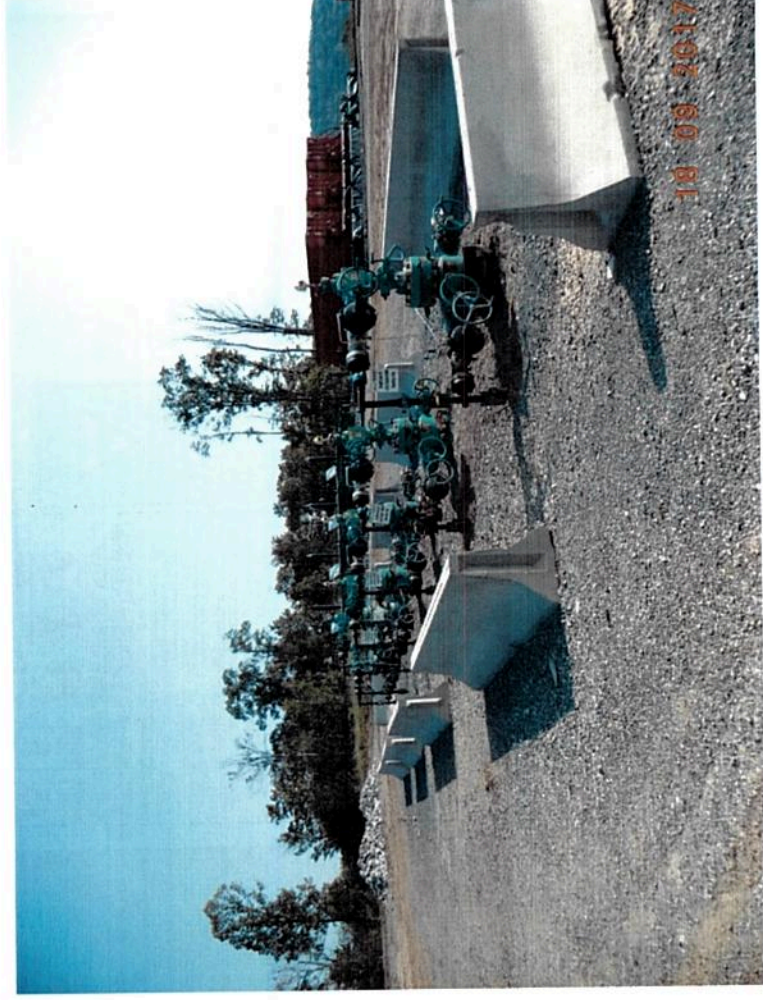
# DSC00524 Hamilton Wells

Following the opening conference, EPA and facility representatives traveled together to the Hamilton wellpad (see attachment 1 for all wellpad addresses and coordinates), arriving at 10:08 am on September 18, 2017. Hamilton consisted of seven wellheads, seven GPUs, and seven storage tanks, plus two Cimarron enclosed combustors and one VRU. EPA observed the site using the FLIR camera and did not observe any excess emissions. The enclosed combustor plume, as viewed with the FLIR did not clearly show excess emissions. At 11:00 am EPA left Hamilton and proceeded to the next site.

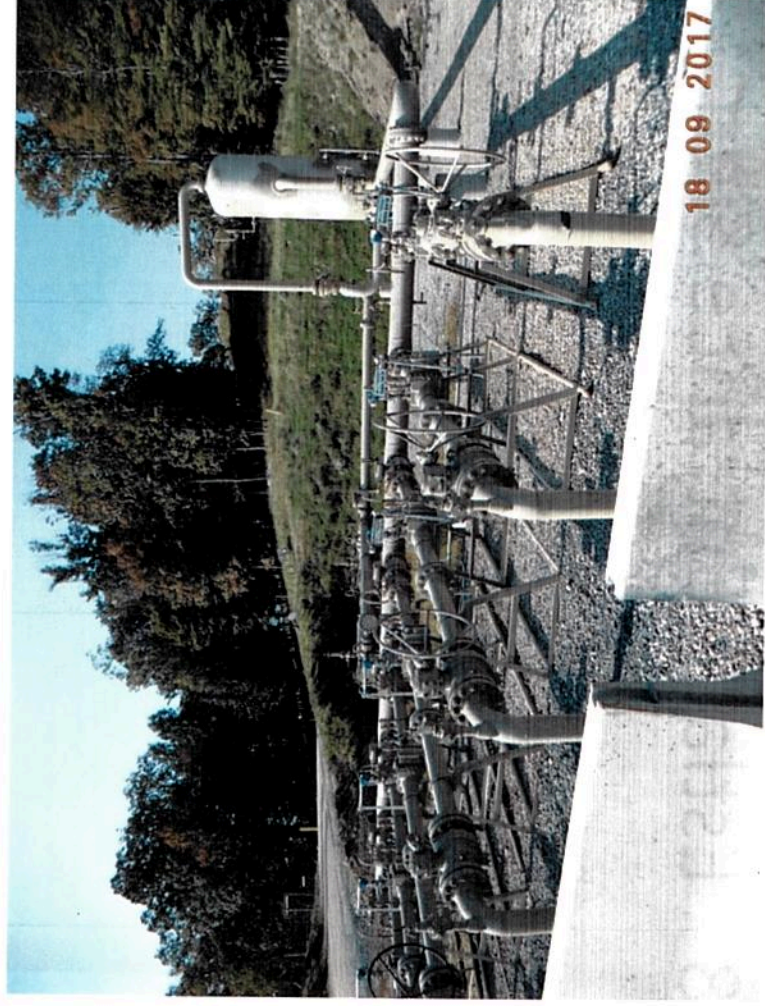
DSC00527      Hamilton Sale Meters and Slug  
Catcher

The 16 sites visited by EPA each have multiple horizontally drilled wells that produce natural gas, condensate and (produced) water. Each site has gas processing units, condensate storage tanks, produced water storage tanks, one or more enclosed combustors, and well heads. Some of the sites are equipped with vapor recovery units (VRU) and/or vapor recovery towers. Although Antero refers to them as VRUs these units do not recirculate any of the gas and instead function as a pump and compressor unit. The gas leaves the site via pipeline. The pipeline is equipped with a sale meter to record flow and a slug catcher to remove liquids.

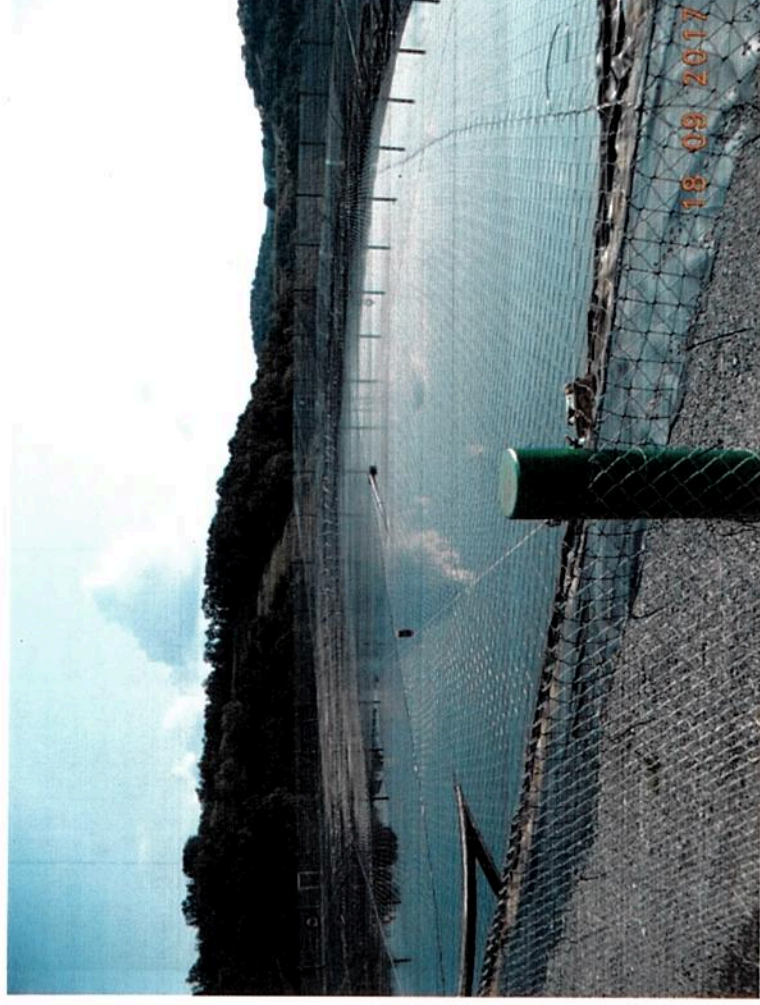
DSC00537 Eddy Produced Water Pond

At 4:07 pm, EPA arrived at the Eddie wellpad. This pad has eight wellheads, eight GPUs, and eight tanks, plus one enclosed combustor, one VRU, and a lined, produced water lagoon. The lagoon stored water produced during the fracking. It was open to the air but covered with a net to keep birds out. EPA walked around the perimeter of the produced water pit and observed a slight hydrocarbon odor. EPA also used a photoionization detector around the perimeter and recorded <10ppb at all points. Using the FLIR camera, no excess emissions were detected from any tanks or other equipment at this site, however, the enclosed combustor, unit ID 1359740, appeared to have uncombusted emissions. The combustor was operating at 230°F. EPA left the Eddie wellpad and this concluded the inspections conducted on September 18, 2017.

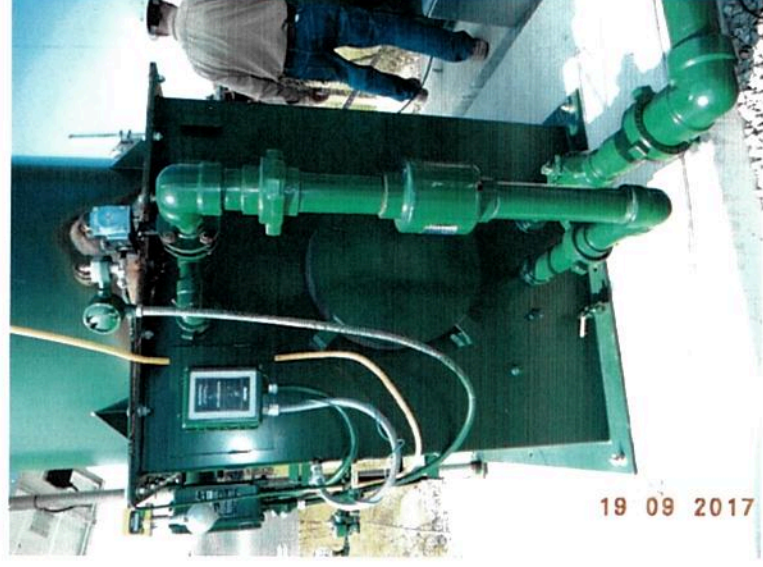
# DSC00539 Primm Flare and Vent Gas Inlet

The following day, September 19, 2017, the inspection resumed at 10:21 at the Primm Wellpad. This site has eight wells, eight storage tanks, and eight GPUs, and two enclosed combustors. EPA surveyed those components with the FLIR camera and found that there appeared to be excessive emissions from the enclosed combustors. Enclosed combustor ID numbers and operating temperatures are shown below:

Primm Enclosed combustors	
Unit ID	Operating Temperature (°F)
1378133	373
1363528	195

During the closing conference, EPA noted that hydrocarbon plumes from enclosed combustors that were running at higher temperatures (~ 500°F– 700° F), as observed with the FLIR camera near the top of the stack, were smaller than those that were running at much lower temperatures. EPA indicated that the combustion efficiency of the enclosed combustors may need to be evaluated by Antero to ensure that they are operating as designed. EPA and Antero discussed the possibility that changes in liquid production over the life of the well could be a factor in enclosed combustor efficiency. Ms. Lee mentioned that she had already spoken with Mr. Barry Schatz of Antero’s Denver, Colorado office, and that Antero is resolved to review the design and efficiency of all its 209 Cimarron enclosed combustors, and to contact Cimarron for advice.

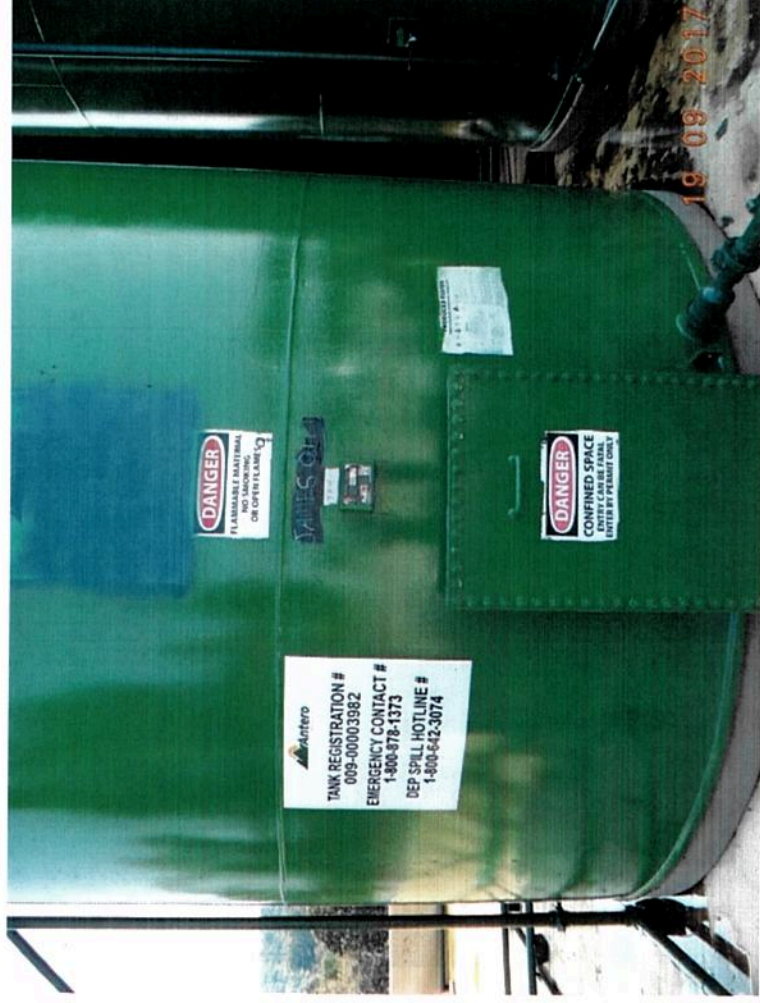
# DSC00541 Robert Williams Tank

At Robert Williams, emissions were observed at the top of tank 009-00003982. The tank contained produced brine water and condensates. Antero representatives repaired the leak by tightening a hammer union; no emissions were detected afterwards. No other equipment emissions were identified at this site in either the wellheads or GPUs. The enclosed combustor at Robert Williams, unit ID 12363526, was pulsing and EPA noted it was operating at 84°F. FLIR video of the combustor appeared to show excessive emissions. EPA left the site at 11:52 am.

EPA also noted that the inspection revealed one small excess emission at the Robert Williams wellpad storage tank that was repaired on site. Additional emissions from equipment was found on vapor recovery units at the Estlack and Mackay wellpads.
